ANALYZING GEOMORPHIC EFFECTS OF THE SEPTEMBER 2013 FLOOD IN FOURMILE CANYON, COLORADO, USING LIDAR AND FIELD STUDIES

WILL WICHERSKI, Williams College Department of Geosciences

Research Advisor: David P. Dethier

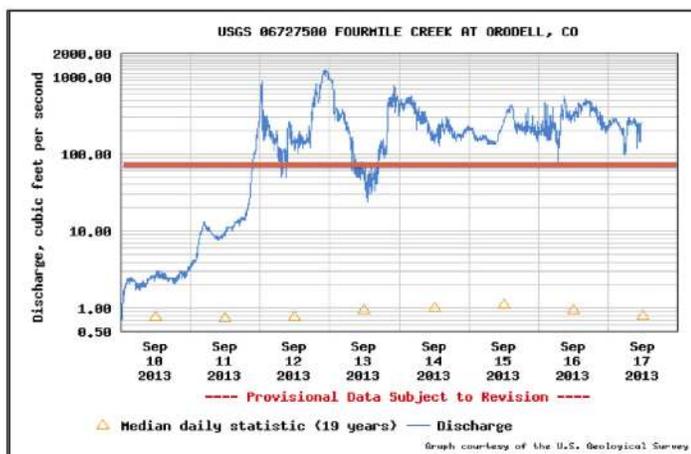
Figure 2. Provisional hydrograph for Fourmile Creek at Orodell, Colorado, red line indicates bankfull discharge (US Geological Survey, 2014).

Flashy rainfall-driven events during the summer months often account for the annual peak discharge events in the Front Range, and can be amplified by wildfire (Moody and Martin, 2001). These events generally are characterized by a short period of very intense rainfall (>200mm/hr) with ‘flashy’ hydrographs that cause short-duration floods such as the Big Thompson flood of 1976 (McCain et al., 1979). However, the September 2013 flood had relatively lower rainfall intensity (<25mm/hr) sustained over 5 days, from the 9th to 15th (Pitlick, 2013; Coe et al., 2014) (Fig. 2). This meant that while the peak discharge was high, the 5 day bankfull duration was the most unusual aspect of the flood (U.S. Geological Survey, 2014) (Fig. 2).

The September 2013 flood was exceptional in many ways, lasting for over 5 days with multiple peak flows (Fig. 2). The flood was also an extremely complex event, with a plethora of sediment sources, contributing factors, and local exceptions. The geomorphic effects of the flood (deposits, erosion, etc.) were affected by the knickzone found midway up Fourmile Canyon and by debris flows that entered Fourmile Creek near Salina and above Wood Mine (Fig. 1). Upstream and downstream from the knickzone, the floodplain widens to 30-80 m across, resulting in more areas of channel migration and major deposition during the flood (Fig. 5). Within the knickzone the floodplain is 15-25 m wide and locally bedrock-floored. Slopes range from 0.02-0.035 above the knickzone, 0.025-0.053 within the knickzone, and 0.02-0.038 below the knickzone. Although width had some affect on deposit occurrence, channel migration, local scour and fill, and large woody debris from the long flood event and debris flows were also contributing factors. Since large deposits are found throughout the channel reach, local slope is clearly not the dominant factor in deposition. The pattern of deposition and erosion we see today is the last overlay of the flood events, locally recording the reworking of deposits from earlier stages. Debris flows

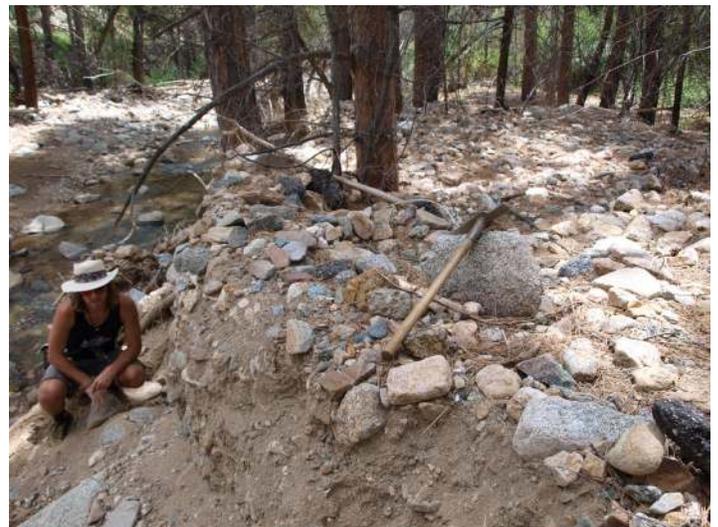
Figure 3. Flood deposition in Logan Mill; coarse deposits are 1.5 m deep; grubber for scale.

This study uses a combination of field methods and LiDAR analysis to characterize the geomorphic effects of the September 2013 flood. The study stretch of Fourmile Canyon was chosen due to its accessibility and dramatic flood response (Fig. 3). I mapped a 15 km reach of the floodplain in reconnaissance and selected 12 more detailed survey sites, mapping flood deposits, measuring high water marks and floodplain width, making point counts of the gravel-cobble sized surface deposits, and collecting samples of deposit matrices (Fig. 3). These data were then used to estimate discharge with the slope-area and critical-depth methods, which have been developed or applied in high-gradient systems (Jarrett, 1984; Jarrett and Tomlinson, 2000). Geographic information system (GIS) analysis of repeat LiDAR elevation surveys from 2010 and 2013 was used to: (1) corroborate the field data; (2) quantify sediment flux; and (3) make morphometric measurements. With the assistance of Matthias Leopold (University of Western Australia), electric resistivity tomography (ERT) and shallow seismic reflection (SSR) geophysical surveys at two sites helped determine the depth of alluvium and flood deposits.
